U.S. Naval Air Station Moffett Field
Building 24 Re-Use Guidelines
Final

Moffett Federal Air Field, California
.....

June 2002

U.S. Naval Air Station Moffett Field
Buildings 24 Re-Use Guidelines

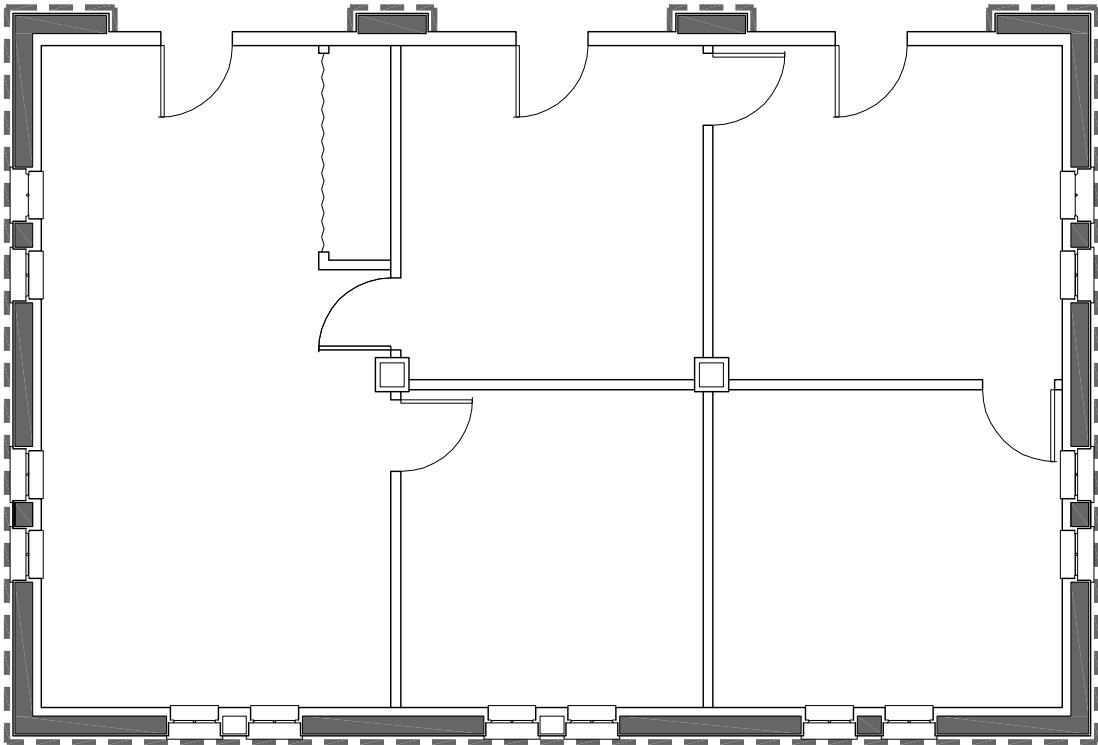
AREAS OF HISTORICAL SIGNIFICANCE

Exterior walls, fenestration, parapet

Interior exposed concrete walls, beams, floor and ceiling

Infill construction in the original garage door openings, gypsum board wall finishes and suspended ceilings

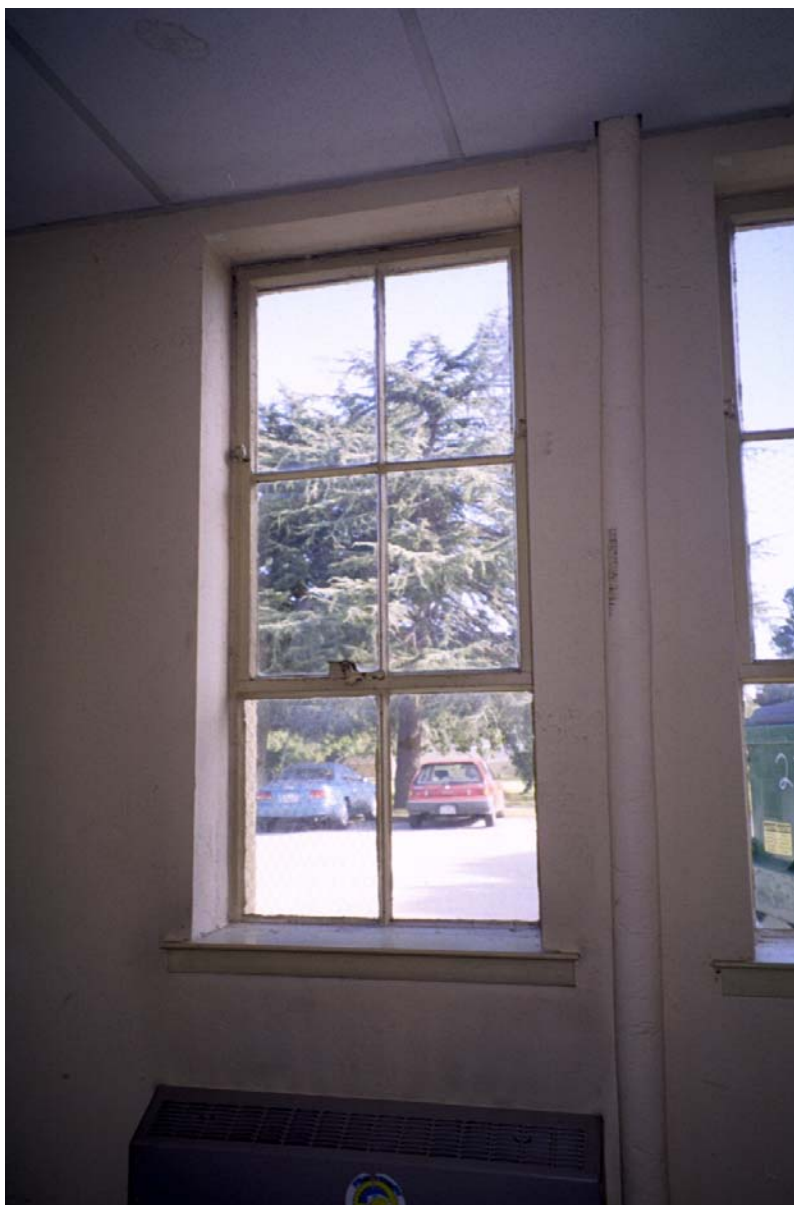
Typical Window, Building 24
December 13, 2001

Building 24 is in good condition overall. The doors and windows are in need of repair. With the exception of limited code compliance issues, and seismic upgrades, the building could be re-occupied with relatively little alteration.

As historic building, Building 24 is exempt from energy code requirements, however measures to reduce energy consumption and provide for user comfort are recommended. These may include ceiling insulation, and exterior wall insulation where the walls are opened during construction. The existing steel sash windows are historic features and they should be repaired and weather-stripped rather than replaced.

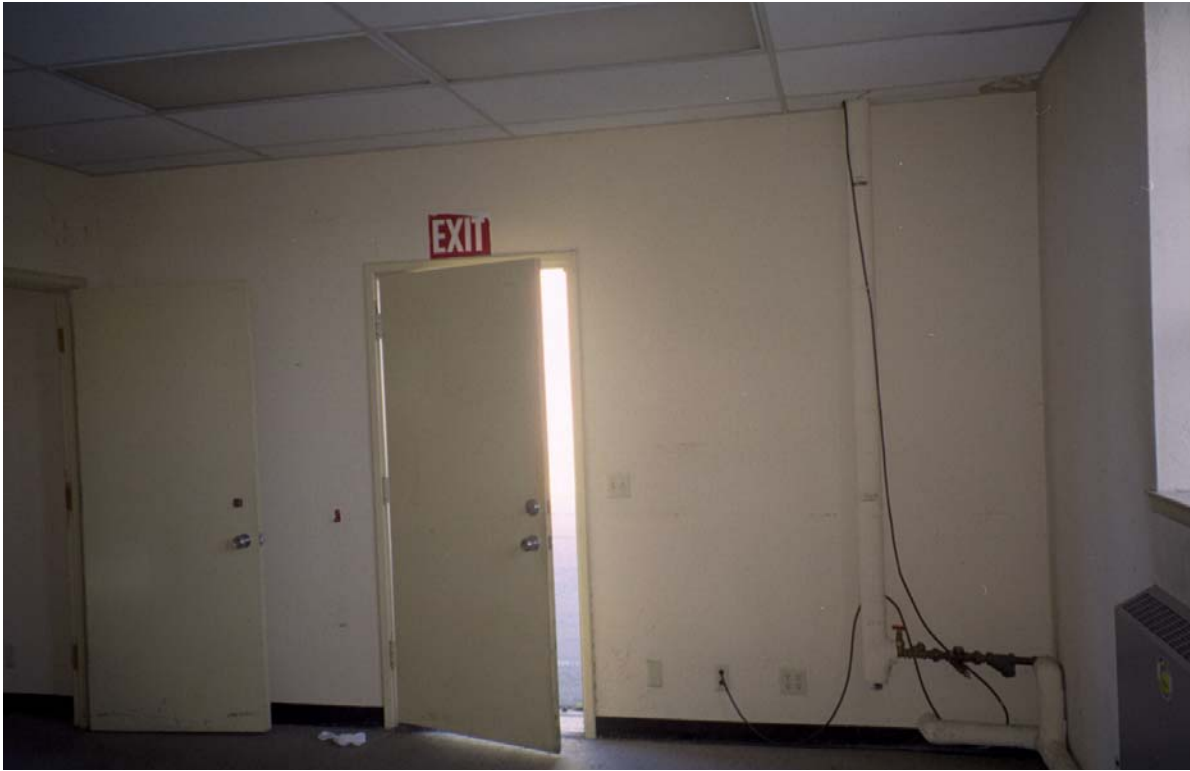
Interior, Building 24
December 13, 2001

Building 24 was constructed along the primary north/south axis behind Building 23 as the ambulance garage. The building is subdivided into three bays. The center bay is emphasized by a raised parapet suggestive of a mission style espadana. The interior of the building 24 has been altered from the original bare concrete finishes into offices with gypsum board wall finish, suspended acoustical ceiling tiles and carpet flooring. The original garage doors have been removed and the openings in each bay have been infilled with stucco wall construction, and a man-door.
